# Video Monitoring Improves Brewery Trub Removal and Prevents Cross-tamination of Batches

*Brewery product quality requires close attention to process variables throughout the production cycle. The use of a sight-glass camera on process vessels can help prevent product loss.*

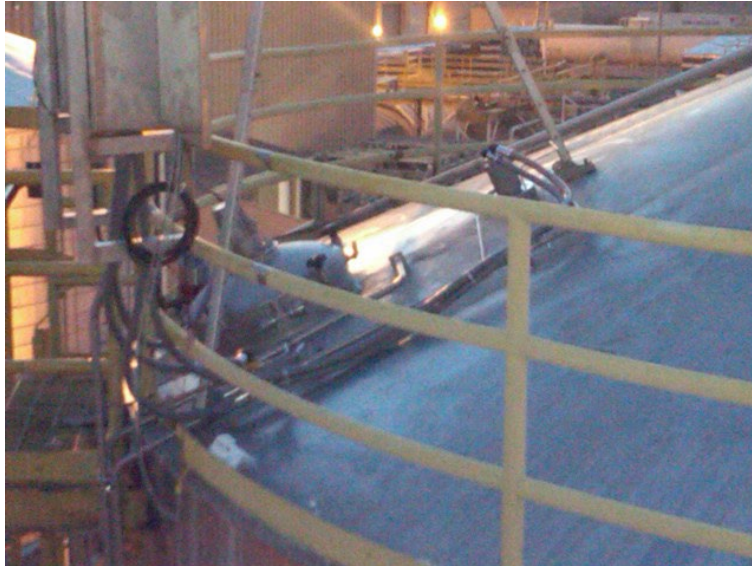
Figure 1. Brewery whirlpool tank where the video camera is installed.

The application environment for the camera was the main factor in other companies declining to submit a bid. The camera must be mounted on top of the whirlpool tank, which places it outdoors and exposed to the full range of environmental conditions. In addition to heat from the sun, heat from the whirling wort is transmitted to the camera through the sight-glass assembly. This can raise the temperature of the camera housing to more than 100°C.

A Lumiglas® Model K15 VISULEX color video camera supplied by L.J. Star was installed on the existing sight-glass in the top of the whirlpool tank. A second sight-glass with a high intensity discharge lamp was installed to provide sufficient continuous illumination inside the tank for the camera. Then initial testing was conducted to see how the system performed. Two problems were uncovered during the first few trial runs. First, condensation from the whirling wort collected on the sight-glass, obscuring the camera's view inside the tank. Second, the temperature of the camera housing rose so high that there were periodic faults in the transmitted video image.

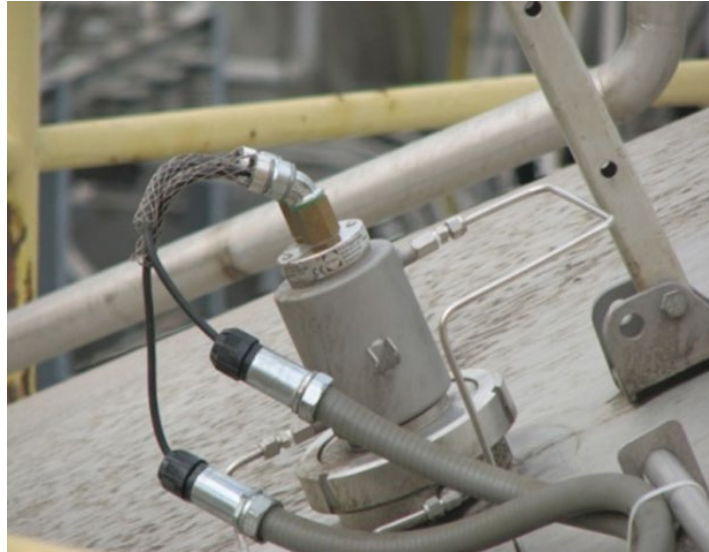
Figure 3. Camera installed in an air-cooled housing.

To solve these problems L.J. Star technicians replaced the standard sight-glass with one that had a hydrophobic coating. This allowed the glass to shed condensation more easily. Then the camera was installed in a stainless steel air-cooled housing. Airflow (5–8 psi) was controlled by a solenoid-operated valve tied into one of the brewery's PLC systems. The PLC logic was programmed to turn off airflow whenever there was no process activity for eight hours.

The K15 Camera is available with either a fixed lens or zoom lens and has a video resolution of up to 480 TV lines. The camera's field of view was easily adjusted to see most of the tank sidewalls as well as the bottom area where trub accumulates. Optional camera features such as automatic control of aperture, focus, and shutter speed can simplify its setup. A camera cable of up to 500m long allowed connection of the video output to a TV monitor in the brewery's control room. This was standard coax cabling with a BNC-to-phono plug adapter for the LCD TV display. Electrical power to the camera and lighting was fuse-protected 120VAC supplied from an auxiliary transformer.
